Why Forensic Analysis is a Critical Step in Motor Repair - Case Study - Part 2

Forensic Analysis of a Silicone Oil Filled Mobile Transformer

Howard W Penrose, Ph.D., CMRP
Dreisilker Electric Motors, Inc.
Glen Ellyn, Illinois USA
hpenrose@dreisilker.com

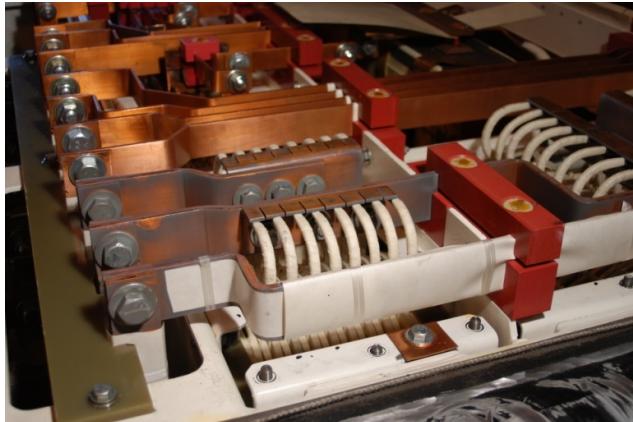
As noted in Figure 1, a grey deposit existed throughout the transformer. Several possibilities were considered and a sample was sent for laboratory review.

Fig 1: Grey Matter on Bus Bars

The material was identified as mainly made up of silicone, aluminum, copper, iron, zinc, magnesium, calcium, sodium and titanium (Table 4). The material was attracted to the bus bars with the metal being made up primarily of the same material as the bolts/threaded rods throughout the transformer. The generation of the material was estimated as having been the result of movement between the threaded rods and suspension springs located with the component buckets (Fig 2).

A majority of the grey material was on a specific electrical filter that should not have been carrying significant current. This allowed the facilitator to identify potential capacitor filter calibration issues, which were reported.

- Periodic tuning of the filter capacitors would be required versus the one-time set up tuning presently performed;
- Several options for mitigating the existing conductive material were presented, but not pursued, due to additional investigations;
- An insulation coordination study must be specified in the original purchase of future transformers;
- The existing insulation system must be replaced upon failure of each transformer, if not before;
- Acceptance criteria for dissolved gasses and particulate must be agreed to by both the vendor and owner; and,
- The bucket suspension system must be modified to eliminate metal from permeating the oil due to fretting.

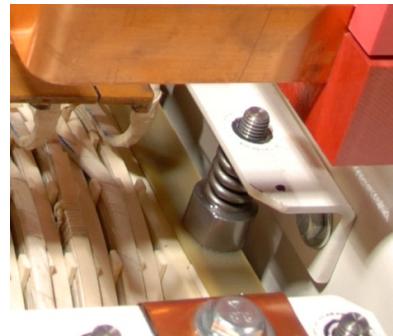
Fig 2: Fretted Bolts and Buckets

It was noted that there was no guide or material between the threaded rods and there were visible signs of fretting.

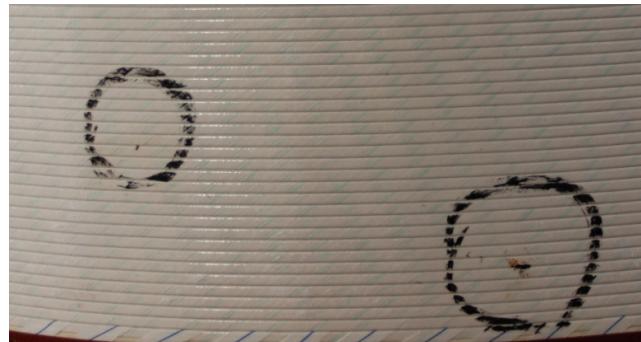
Fig 3: Burn Spots Between Primary Conductors

As identified in Figure 3, there were ‘burn spots’ throughout the primary between conductors in the center layers, with the copper conductors visibly pitted directly underneath. There were other areas where the grey matter could be found attached to the tacky insulation paper. It was determined that the ‘arcing’ noted in the oil samples may have resulted from these indicators. It was also noted that the pictures in the first transformer failures showed the faults occurred in roughly the same area as the ‘burned’ spots in the sample primary. The tackiness was attributed to possible incompatibility of the conductor varnish with either the silicone oil or the dissolved gasses.
