***Why Forensic Analysis is a  
Critical Step in Motor Repair -  
Case Study - Part 1***

# Forensic Analysis of Multiple Medium Voltage 3MW Self-Excited Generators Following Field Testing

Howard W Penrose, Ph.D., CMRP  
Vice President, Engineering and Reliability Services  
Dreisilker Electric Motors, Inc.  
Glen Ellyn, Illinois  
hpenrose@dreisilker.com

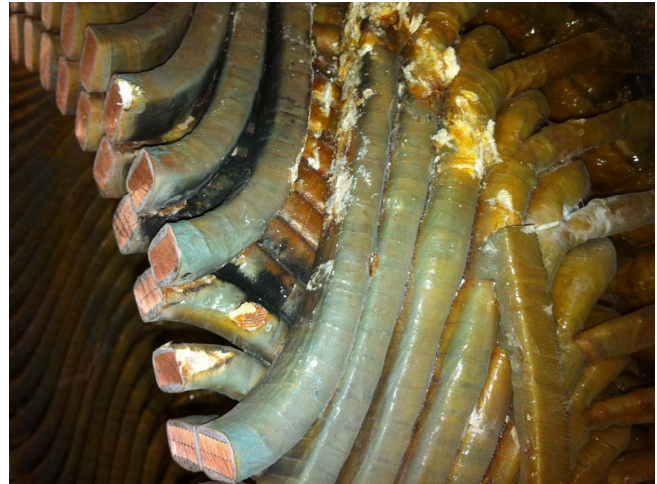
- Pinhole short: caused by high impulse, lightning strikes, high voltage testing.
- Aging/brittle insulation: an aged insulation system either because of general age or accelerated aging due to overloading, overheating, or other cause (Reference Figure 1).
- Contamination/foreign object: an object impacting winding.
- A turn short causing ground when it burns through the insulation system.

A visual inspection of the windings and removal of the coil indicated that the winding had aged. A review of past insulation resistance testing indicated that the insulation resistance had gradually been increasing from year to year. This would indicate that the insulation had been gradually aging over time.

Figure 1. Aged Insulation System

It was determined that the winding had been aged and the insulation was brittle. The maintenance tests were performed during a period of high humidity. Although the third party testing company denied performing high voltage testing it appears that may have been one of the conditions that led to the failure based upon tracking evidence.

- Proper tracking of insulation resistance readings is recommended such that increasing test results with temperature correction actually indicates aging insulation.
- Polarization Index (PI) trending would also be recommended including monitoring the PI curve [3].
- Ensure high voltage testing is not performed on the machines when the winding temperature is below the dew point.
- Replace aged insulation as opposed to dipping and baking using epoxy varnish. While this step increases the maintenance costs, the higher cost is associated with unplanned outages. A trade-off would have to be determined in relation to reliability versus maintenance costs.

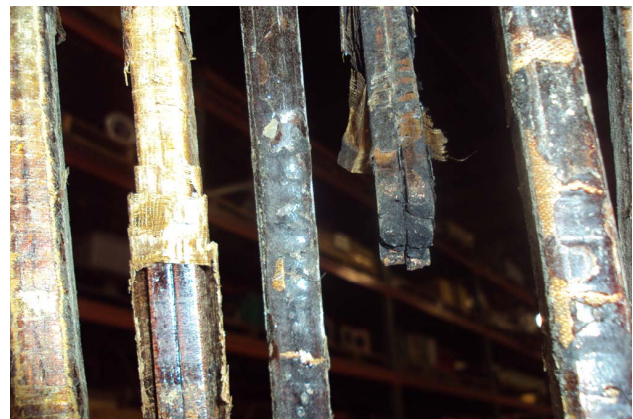
During rewind repair of the first generator the second generator failed at the same location during operation a few months following field testing. The insulation was found as Figure 2. The initial review identified a similar history as the first generator, so testing and RCFA was also performed.

Figure 2. Failure Point and Surrounding Coils 2<sup>nd</sup> Generator

The team determined that the initial step would be to follow the same fault tree as with the first generator. The results were similar other than the point of fault where the conductors had vaporized as it had failed under load. It was evaluated as a latent fault.

The overall conclusion was that a combination of aged insulation, humidity and high voltage testing damaged the insulation systems of these generators causing one to immediately fail and the second to have a latent fault that shorted to ground during operation. The primary concern has been that there is a large fleet of generators of about the same age in the field requiring a review of testing history and operating environment.
